Butte Fire

State Post Fire Watershed Emergency Response Team
Addendum I

Hazard Site Evaluation

October 2015

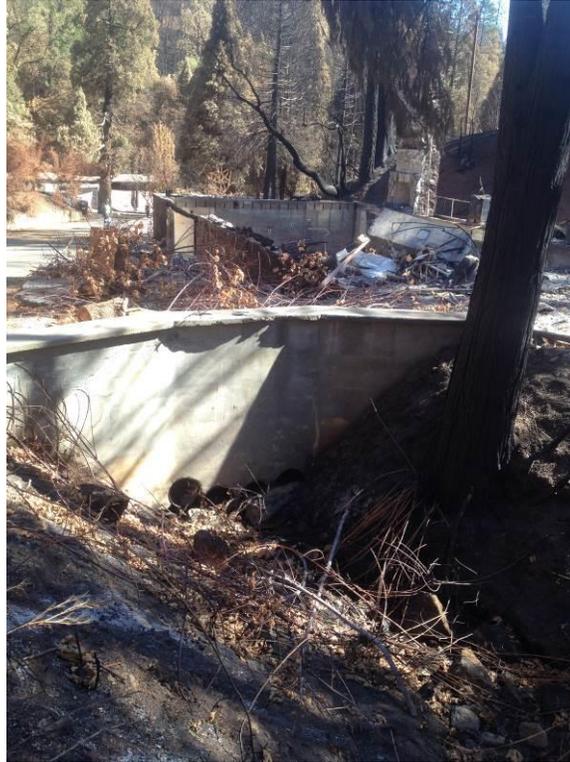
Site Number 1

This home was burned in the fire. It is located on West Murray Creek Road and was built on top of an unnamed drainage that flows to Murray Creek. No street address could be located on the property but mailboxes at the top of the hill indicate this home is located along West Murray Creek Road.

Four 12" culverts were incorporated into the home's foundation to convey stream flows under the house from the unnamed drainage to Murray Creek. Upon inspection, the culverts were observed to have rusted through and were no longer functioning as designed. In addition, a large outbuilding (burned) and parking area is located next to Murray Creek and susceptible to flooding.

Moderate to high soil burn severity was observed in 90% to 100% of the unnamed drainage upstream of this site. Consequently, much higher (1 to 2 orders of magnitude) runoff and erosion rates are anticipated (compared to the pre-fire condition) and a debris flow may occur during a large storm.

Option 1. If the property is scheduled for commercial clearing and removal by Cal Recycle, the foundation covering the natural intermittent stream course shall be completely removed leaving an open watercourse leading into W. Murray Creek.

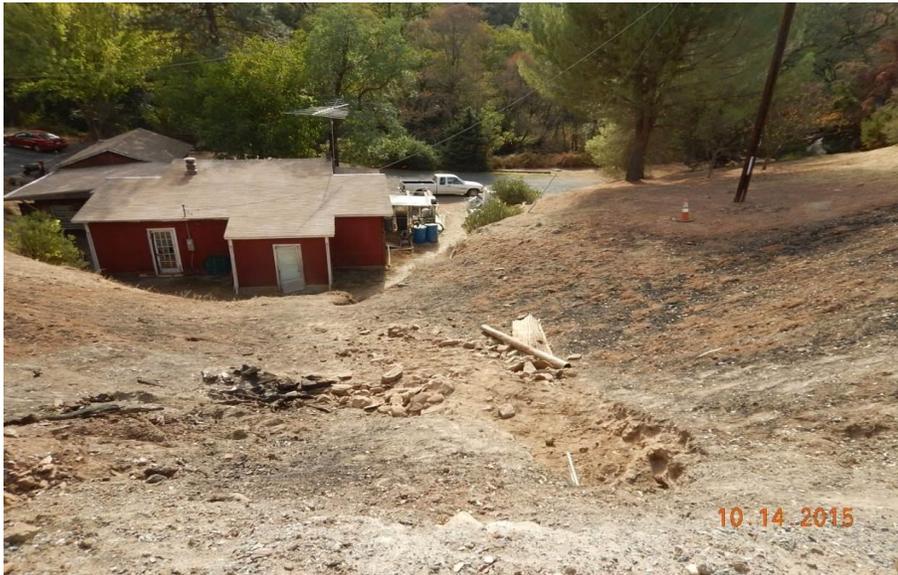
Site Number 2 & 4

House is at the bottom of a hillside, directly below the drainage (approximately 5 acres that was almost entirely burnt). Spoke with owner and tenant. Tenant said that the neighbors are working on getting the 30" culvert opened to allow flow to cross the road providing access to their properties. Outlet of the pipe is buried and will not allow flows. If pipe is re-opened on the downstream end, the flows will discharge down the slope and immediately into the back side of the house. If the pipe is not opened up, debris will build behind the road fill and could potentially lead to overtopping of the road. If this happens, the flows may go down the road or over the slope toward the house.

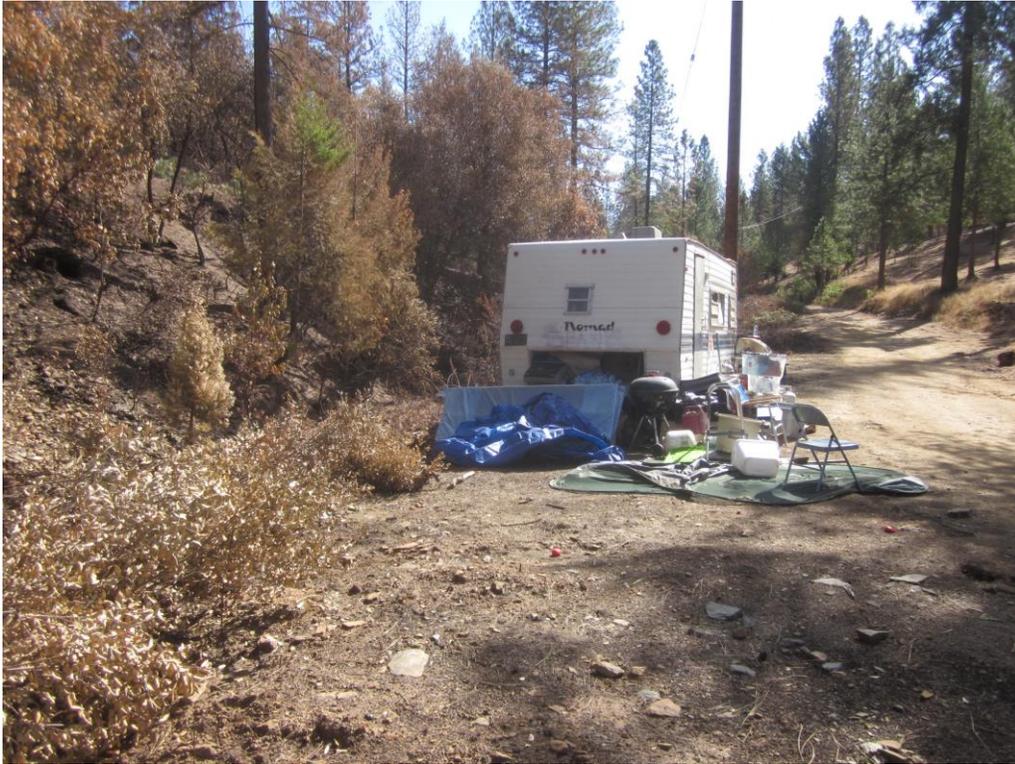
Site Number 3

Travel Trailer on south bank of drainage. Trailer in jeopardy of flooding. Son of owner said that they spoke with CAL FIRE during the week of October 12th and received suggestions to put water bars on the road and to move the trailer to higher ground.

No further recommendations were made because the owner's son said he knew what they needed to do.

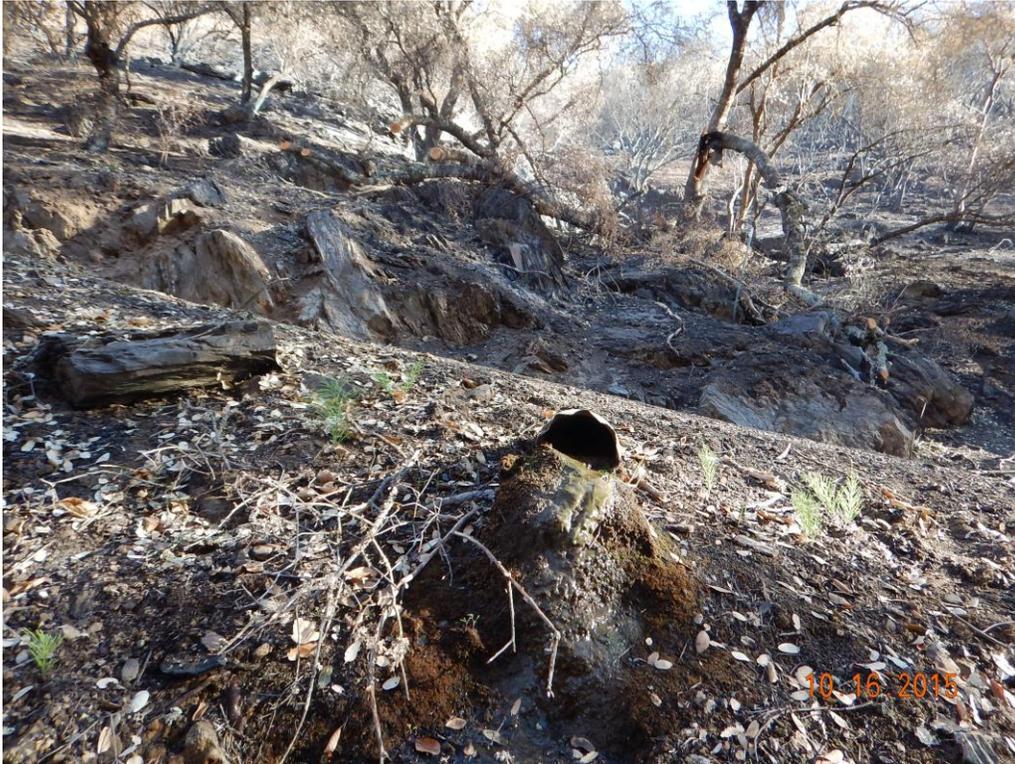
Site Number 5

Jesus Maria Creek runs adjacent to Jesus Maria Road and a culvert provides drainage into Jesus Maria Creek from an upstream channel. The canyon narrows at this point, creating the potential for higher flood velocities through this section of Jesus Maria Creek. The upstream end of the culvert is not visible and is assumed to be plugged.

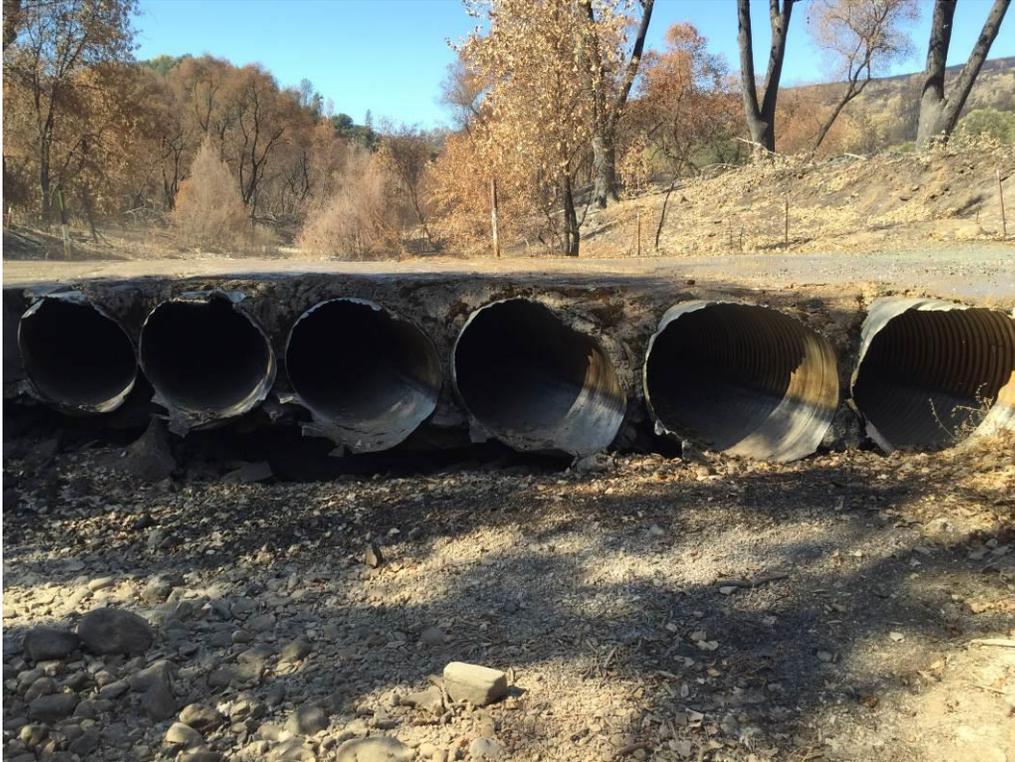
Site Number 6

Six 48" CMP Culverts are located at the Hawver Road crossing of the North Fork of the Calaveras River. In the event of a high intensity rainfall event the crossing could become inundated with flood flows. Hawver Road would become unpassable.

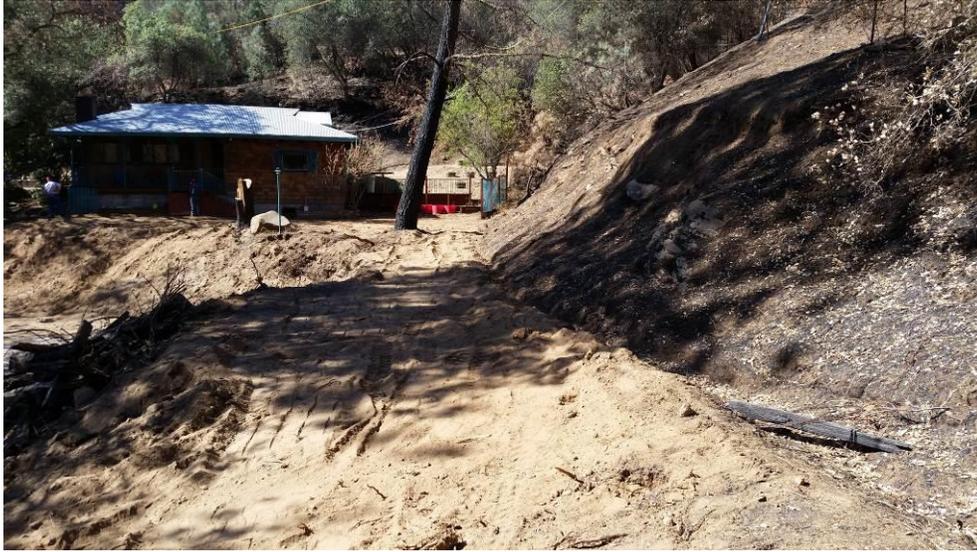
Site Number 7

House is at the bottom of a hillside, adjacent to the drainage. Owner/Tenant were not home. Some concern over flows reaching the home because of increase flows including debris. Inlet to culvert under Highway 26 cleaned and lined with rock riprap. No trash rack or debris catcher in place.

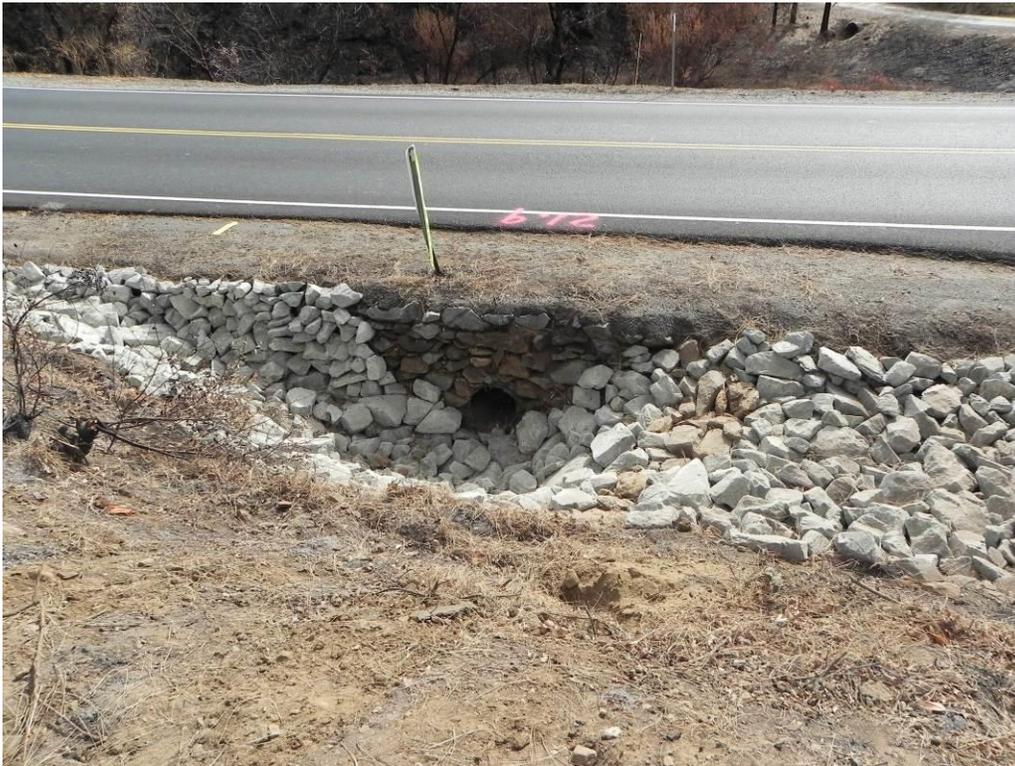
Site Number 8

See Site 7

See Site 7

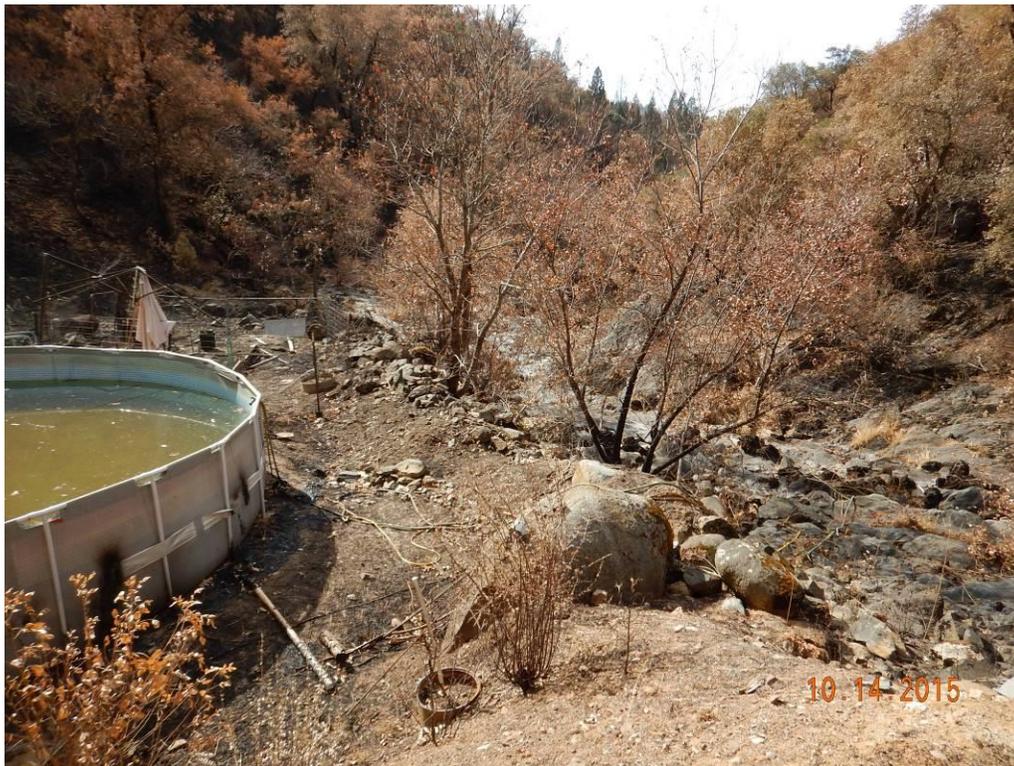
Site Number 9

This site is a burned home located on Cedar Springs Road. The burned home, adjacent pool and yard are located next to Jesus Maria Creek and are susceptible to flooding during high flows. The yard is approximately 6' and the house foundation 15' above the channel invert, respectively.

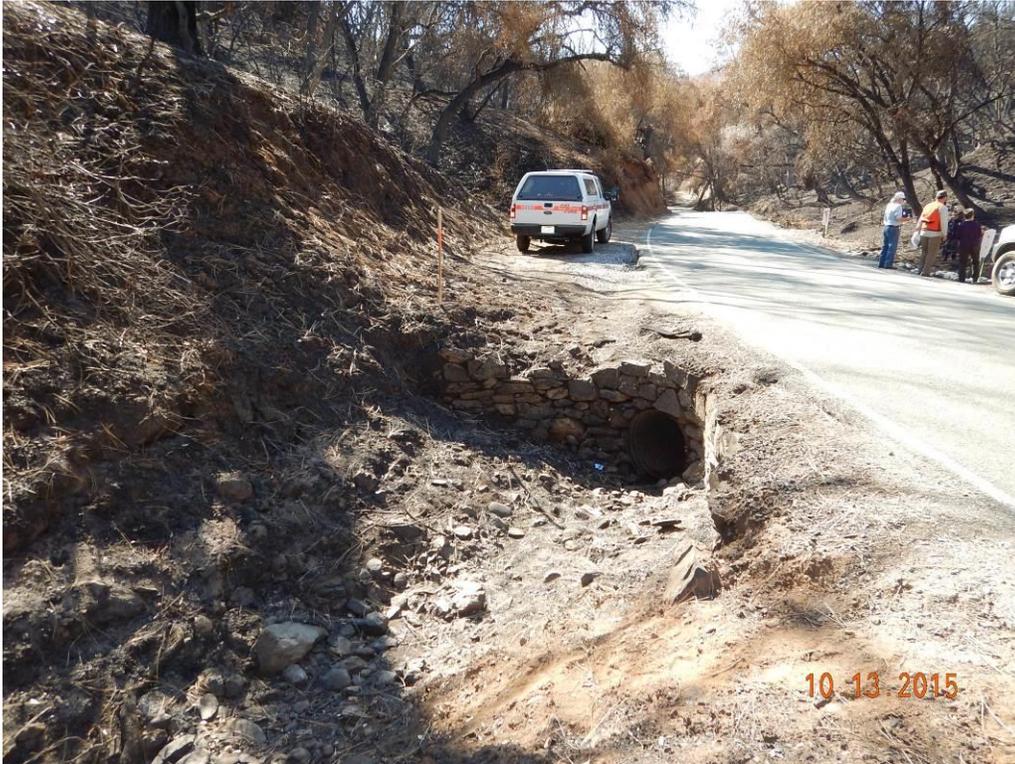
Site Number 10

A 36" CMP culvert provides drainage underneath Jesus Maria Road for the intermittent water course. The headwall surrounding the upstream end of the culvert is an archeological site. On the downstream end of the culvert scour is present along the bottom and right bank of the water course. Debris is present in the water course upstream of the culvert and the potential for debris to enter the culvert exists.

Water Quality: Recommended Emergency Protective Measures (EMPs) for this site may include 404/401 permits If a culvert is replaced or if rip rap is placed in the channel.

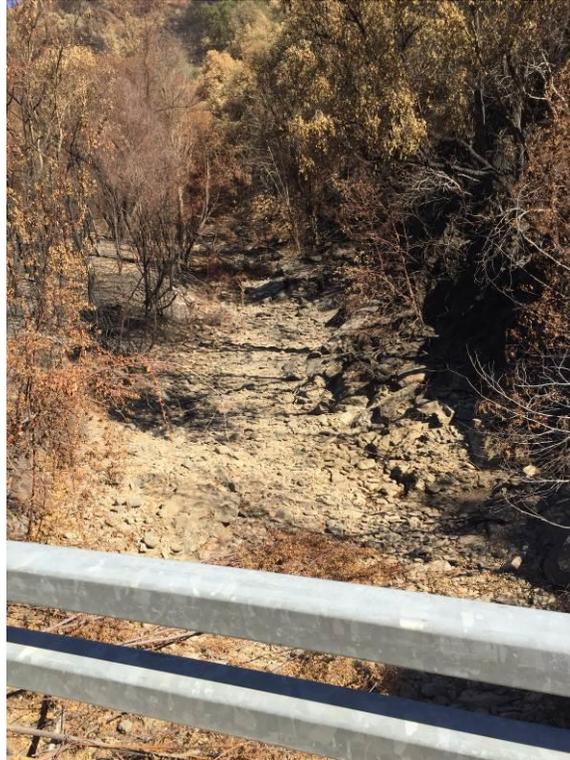
Site Number 11

Jesus Maria Road crosses the North Fork of the Calaveras River via a bridge span. Upstream and downstream of Jesus Maria Road, debris and vegetation can be found in the river bed. In the event of a large storm event the North Fork of the Calaveras River may experience increased runoff and debris flow causing flooding and damage to the bridge crossing.

All other vegetation recommended for removal 30' upstream and 60' downstream from bridge will be removed using hand equipment and cut near ground level. Root structure of cut vegetation will remain intact to minimize soil movement.

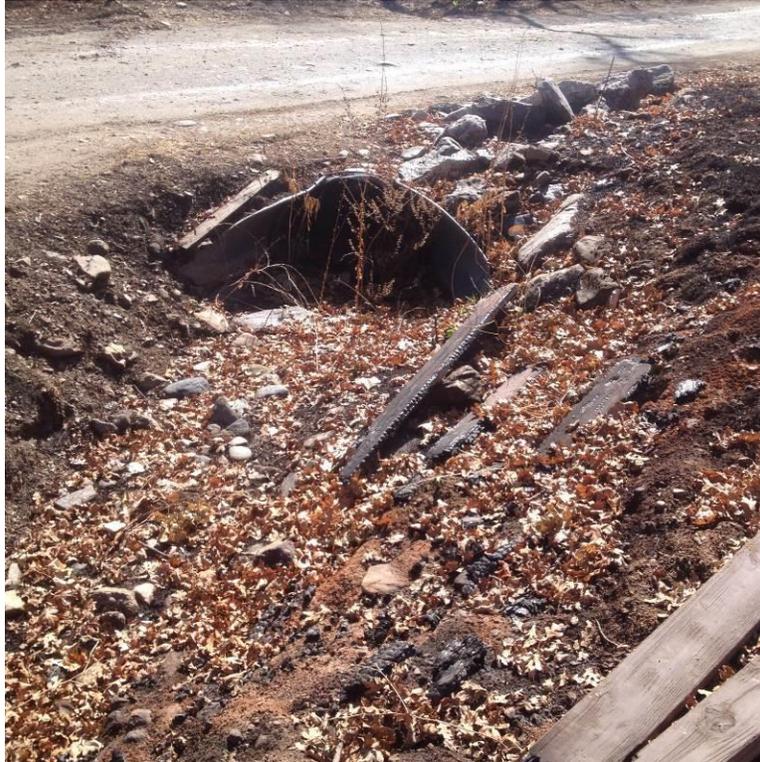
Site Number 12

On Hawver Road approximately 100' south of Jesus Maria Road a 30" culvert crosses Hawver road. Upstream of the culvert the drainage ditch was filled for fire suppression efforts. In the event of a high intensity storm event flood waters and debris could flow from Jesus Maria Road down Hawver road.

Fill placed in the drainage ditch should be removed to restore drainage to pre-fire conditions. If water and debris flow from Jesus Maria Road onto Hawver Road, K-rails or sandbags should be placed to prevent flow down Hawver Road.

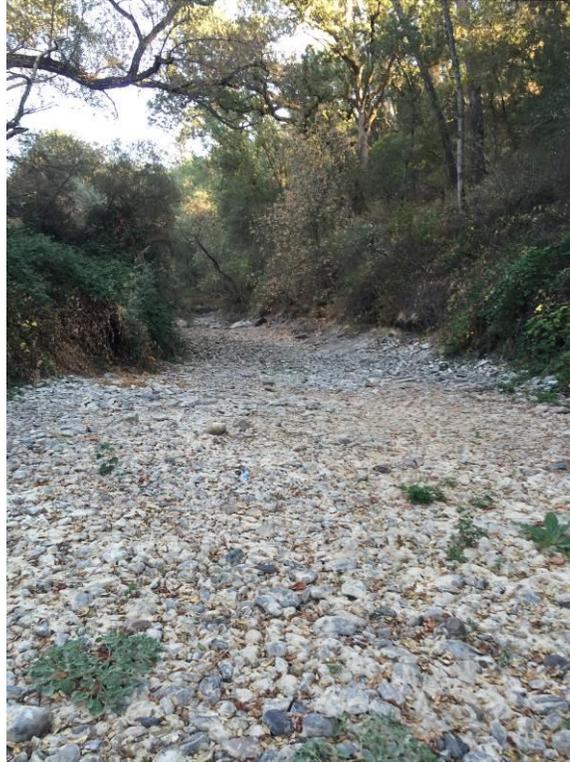
Site Number 13

This site is a low water crossing on Costa Road through Calaveritas Creek. The crossing is unimproved, consisting of tire-compacted creek bed material where vehicles cross the creek. A sign indicating flood hazard is posted next to the crossing.

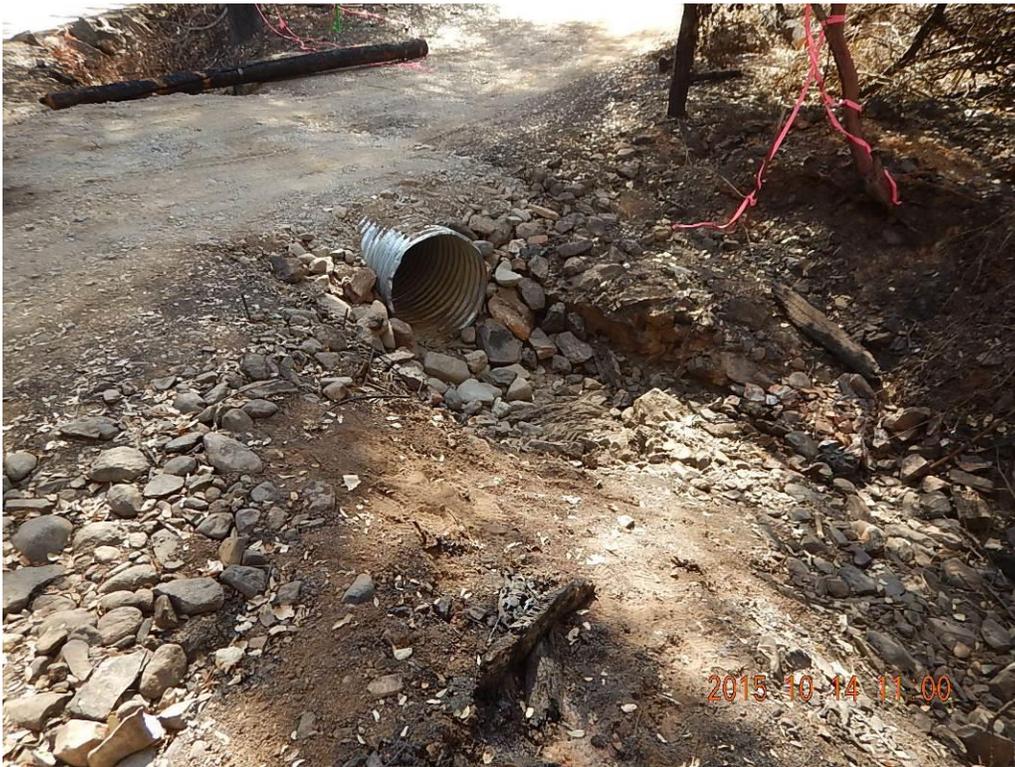
Site Number 15

A timber bridge crossing the intermittent water course provided access to a residence along Jesus Maria Road. The bridge was burned during the fire as well as the residence. A culvert was placed in the former bridge location and covered on top with fill. Vegetation and debris fill the creek upstream and downstream of the culvert.

Remove the culvert and restore the creek to pre-fire conditions by placing a bridge across the creek for access to the property. In the interim debris and vegetation should be removed 30 feet upstream of the culvert and 60 feet downstream.

Fish and Wildlife: Recommending the removal of gravel fill placed around culvert placed in the intermittent watercourse and placed in an area where it cannot re-enter watercourse.

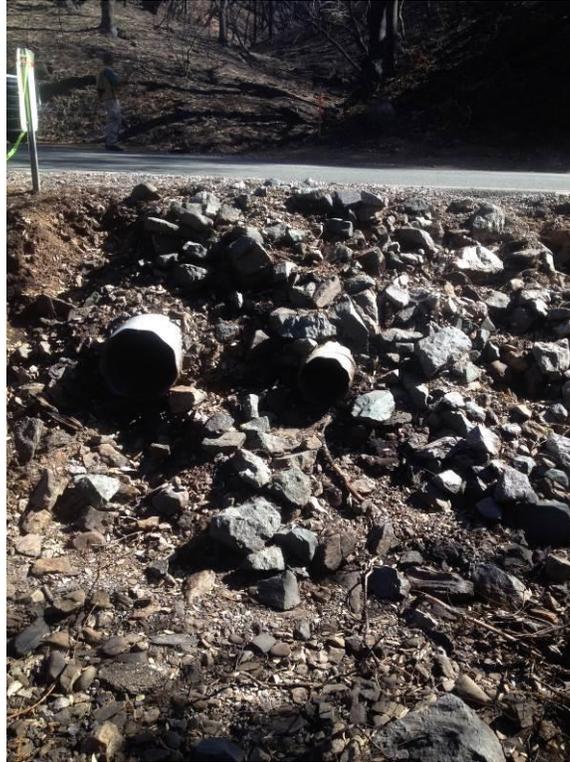
Site Number 16

Downstream of Site Number 10, 2 culverts enter into the intermittent water course. An 18" CMP provides drainage for an upstream channel underneath Jesus Maria Road and into the water course. A second smaller culvert is present on the downstream side, however the upstream end of the culvert could not be located and is assumed to be plugged and not in operable condition.

Water Quality: Requires 404/401 permit for rip-rap placed in creek channel

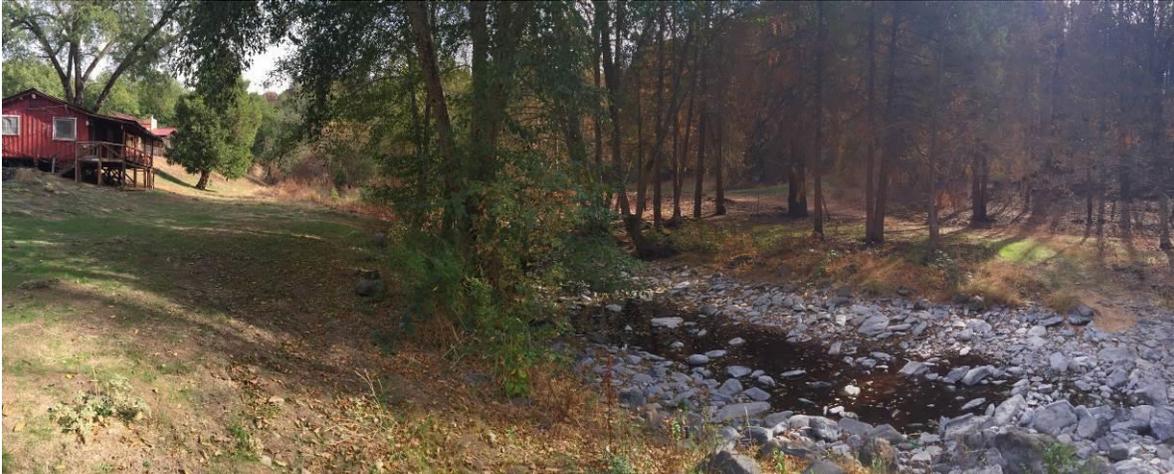
Site Number 17

Two homes on this property. Newer home sits up on a raised hillside pad. The older of two houses is likely in the flood plain and could be damaged during flood flows on this drainage. Spoke with owner who said the older house is not inhabited and that it had nominal value. Calaveras County Roads Department indicated that flood flows (over the last 30 years) have been high enough to go under the raised portions of the home. Also, some woody debris from previous flooding was also observed in the stream, at the upstream approach to the road bridge. County Roads Department will keep an eye on it, and try to send crews out to remove what is already there.

Solution to prevent damage to this home would be expensive. Based on the value of the structure, the benefit/cost ratio is like to be less than 1. One possible solution would be to build a levee around the edge of the house starting on the upstream end and continuing between the house and the stream. The County has not stated whether or not they would be interested in sponsoring a project here. They did express a concern with house being dislodged and moving downstream. He also had a concern with whether or not there is asbestos in the house's construction.

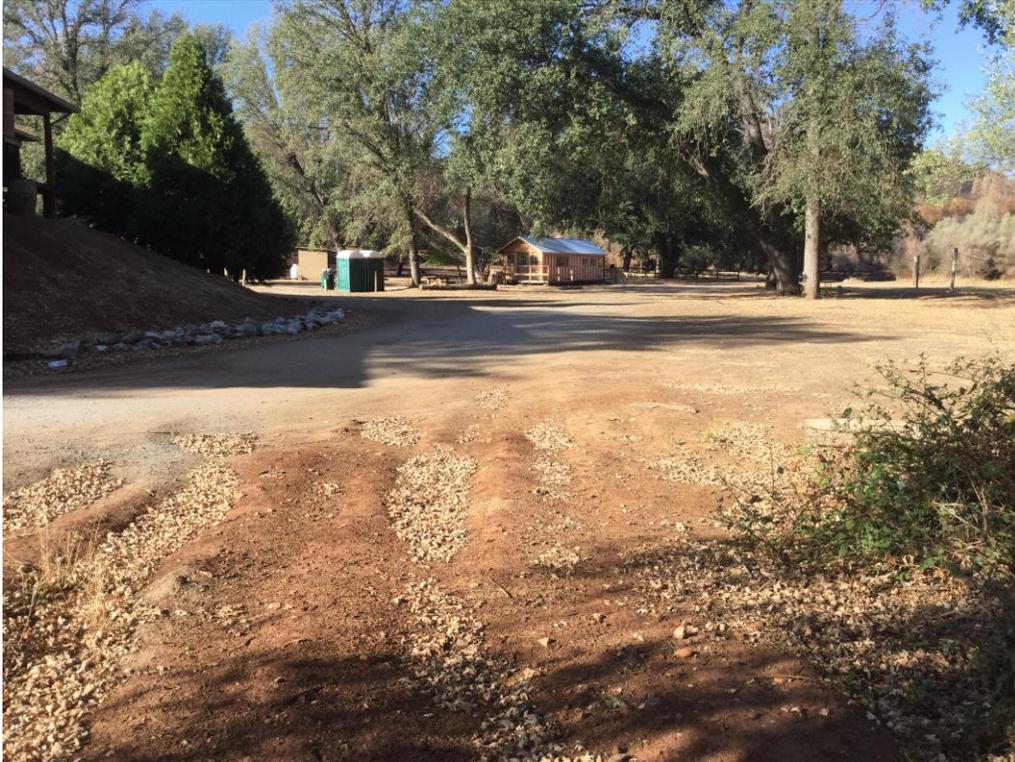
Site Number 19

The watershed upstream of California Caverns is large and has high burn intensity. Floodplain downstream of confluence of McKinney Creek and Martin Gulch is wide and should attenuate debris flows. The main building is up on a terrace and should not be at risk. Outbuildings and the lower parking lot are in or adjacent to the floodplain and may experience "Zone X" type inundation during high runoff events.

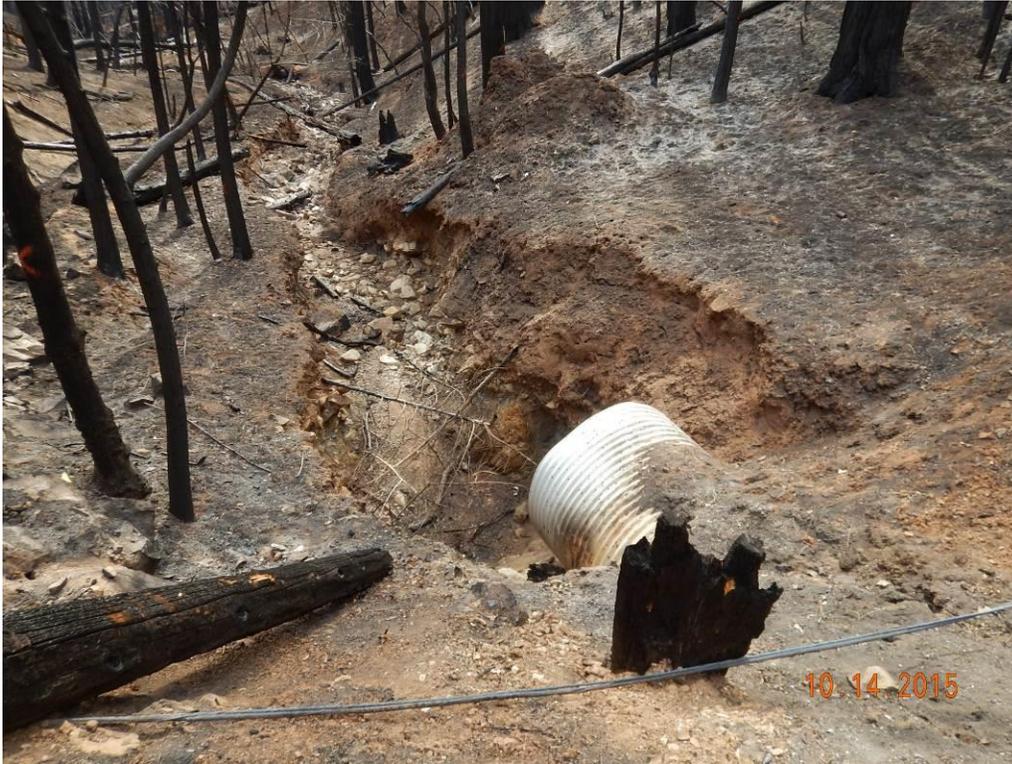
Site Number 20

This is a 60" culvert crossing located on Old Emigrant Trail west of Hangman's Tree Road. The culvert exhibits a deep scour hole at the culvert outlet that is eroding into the adjacent road fill. The culvert is partially crushed underneath the road and will not operate at full capacity. On the right bank downstream of the culvert a pile of dirt likely removed from the channel rests on the bank.

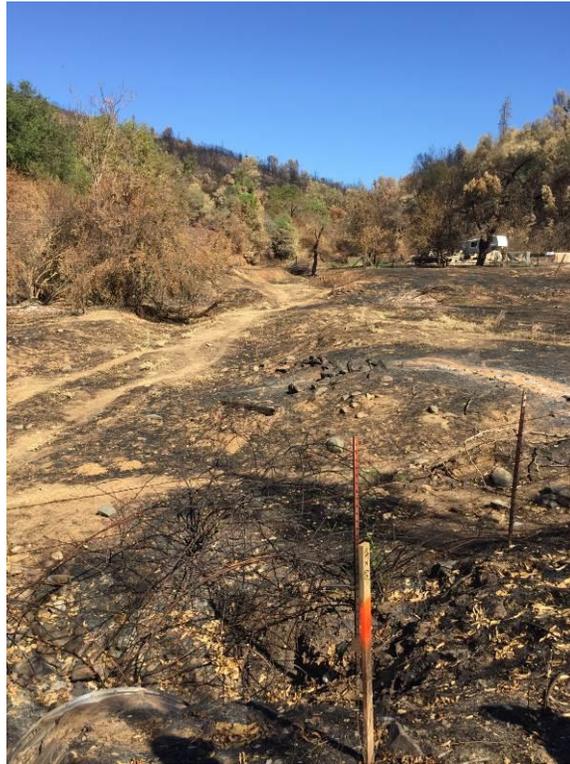
Site Number 21

A 48" CMP culvert provides drainage underneath Jesus Maria Road into Jesus Maria Creek. During a high intensity rainfall event debris may collect and flow into the culvert.

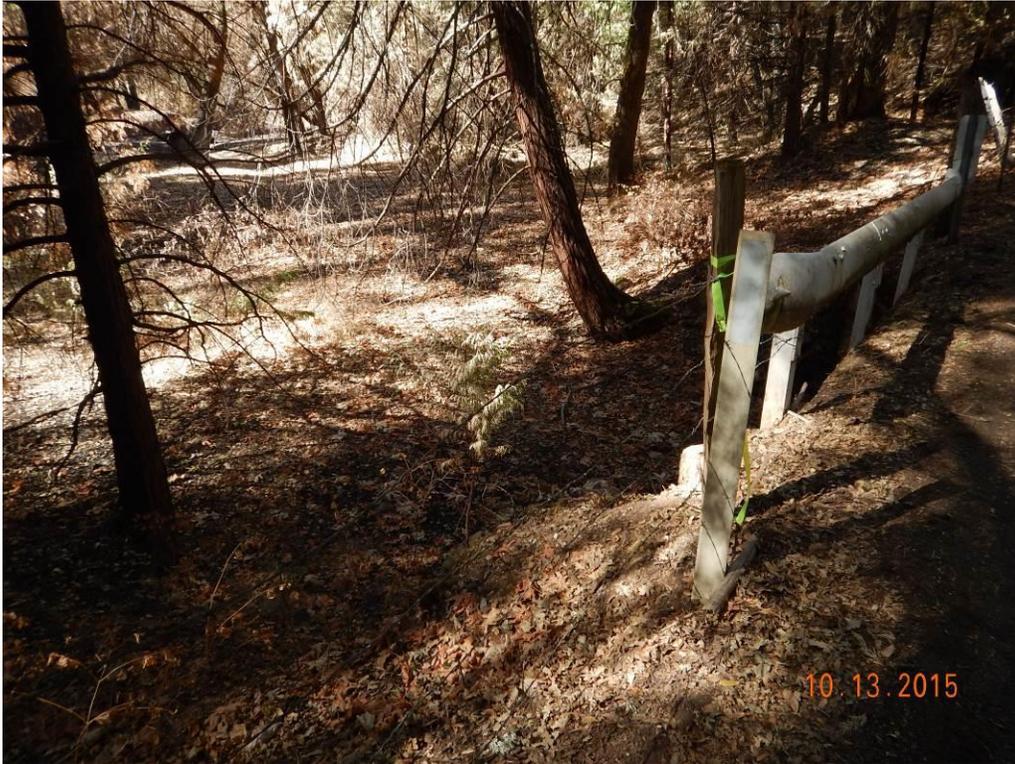
Site Number 22

The site contains an 11'x5' box culvert, located at Whiskey Slide Road crossing Wet Gulch. The site has a moderate risk of flooding and debris flow.

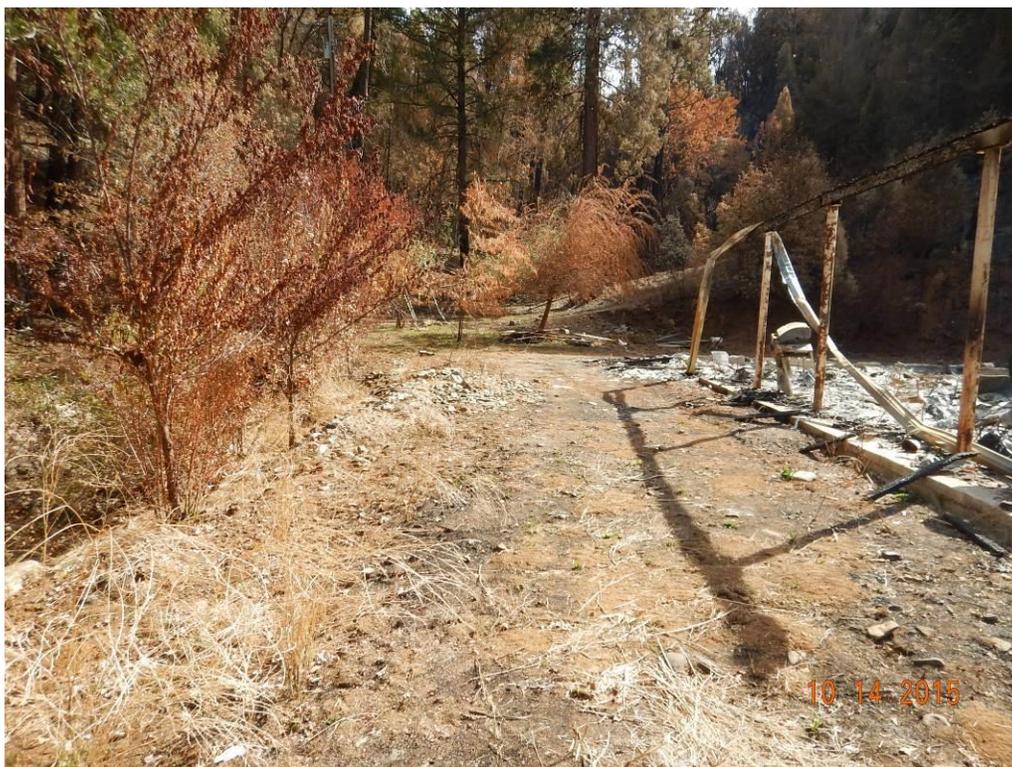
Site Number 23

This site is a burned home located at the base of an unnamed drainage and susceptible to a debris flow and flooding. The burned home is located on Cedar Springs Road off South Railroad Flat Road. Moderate soil burn severity is observed in more than 50% of the unnamed drainage upstream of the site. Consequently, much higher (1 to 2 orders of magnitude) runoff and erosion rates are anticipated (compared to the pre-fire condition).

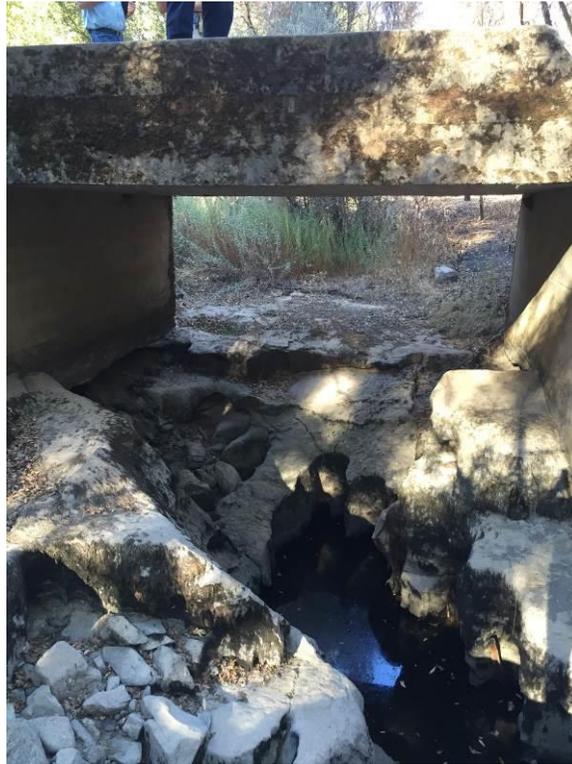
Site Number 25

A small bridge is located at this site where Cave City Road crosses Martin Gulch. The bridge opening is approximately 14' wide by 6' high. The road slopes down to the bridge from both directions. The bridge is located about 200' downstream of a 25' high sediment retention dam near California Caverns.

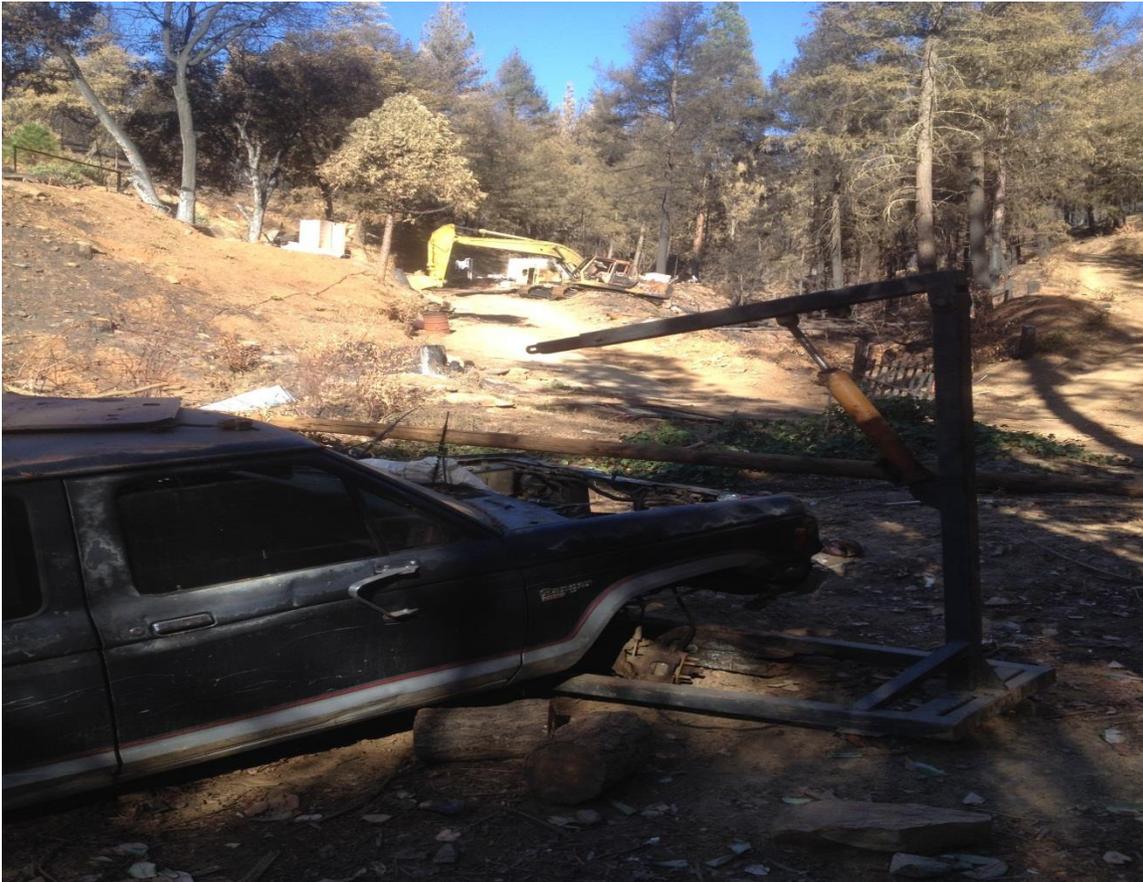
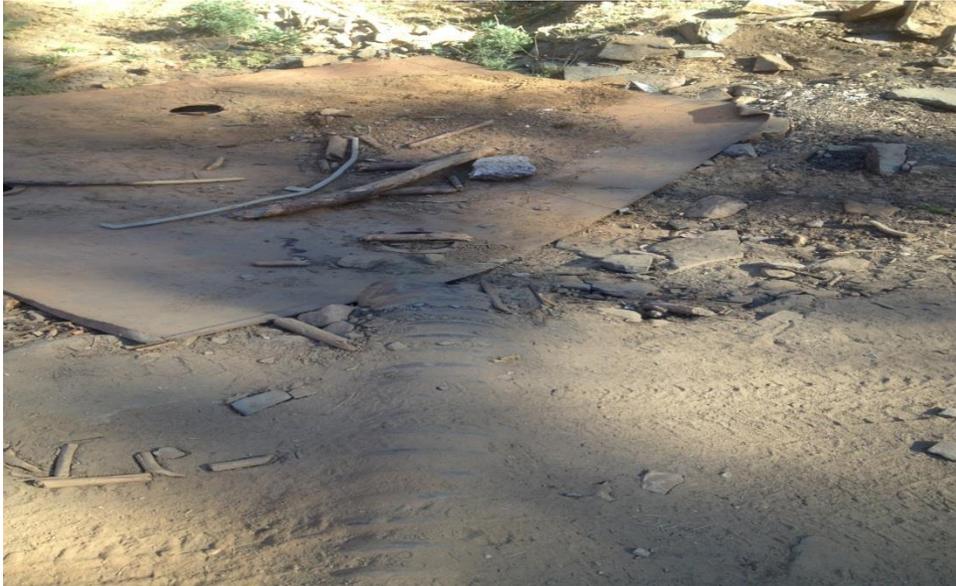
Fish and Wildlife Site Number 27

This site is not identified as a life safety hazard. This site is located in Salamander Gulch below Site 3. It is located at (38 14.263 N 120 35.315 W). It contains heavy equipment and associated hydraulic fluids burnt in the fire as well and a residential site which are all in close proximity to the Salamander Gulch. This site is also an open surface mine without adequate erosion control mechanisms in place. Due to slope gradient, soils, road alignment, and potential for hazardous materials located at this site, it makes site 27 a threat to downstream natural resources.

Habitat type is sierra mixed conifer with and understory of chaparral all of which was moderately burned. The area shows evidence of heavy water flows and failed culvert which is completely buried. See below photo:

Replace failed culvert within Salamander Gulch. Protect the watershed from mobilizing hazardous materials in the watershed. Remove heavy equipment and vehicles from the site to minimize the risk of hazardous materials entering the downstream waterway. Stabilize active mine erosion sites. Contact local CDFW Wildlife Officer or OSPR Officer and notify of site conditions.
