STATE FOREST NOTES

No. 15

July, 1963

A STUDY OF POSTS IN EL DORADO COUNTY

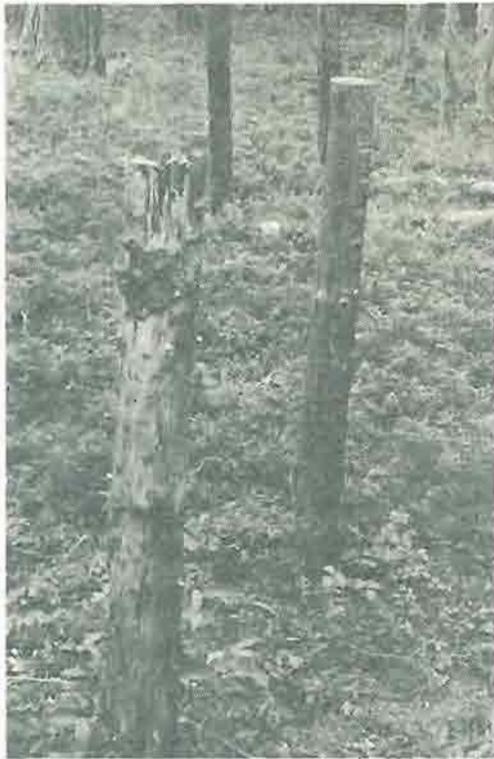
Fig. 3. Two white fir posts that received the mercuric chloride treatment. Note the decay in the unpeeled post at left as compared with the peeled post.

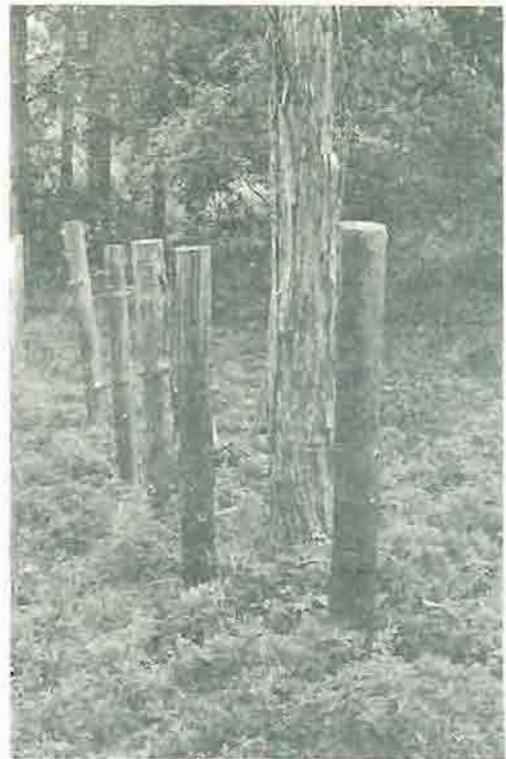
Fig. 4. This row of mercuric chloride treated ponderosa pine posts are all serviceable after 20 years in the ground.

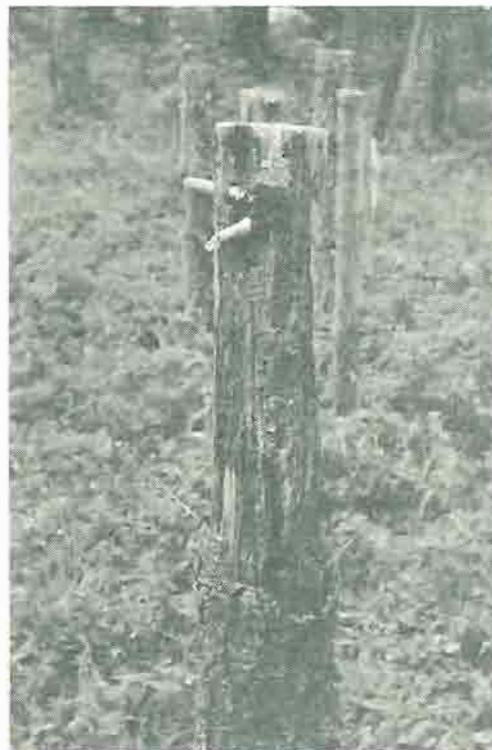
Fig. 5. This zinc chloride treated white fir post is still firm in the ground despite top decay.

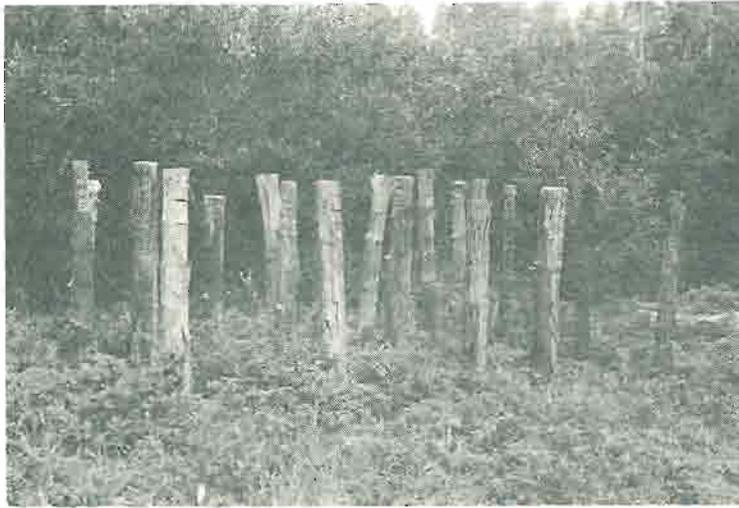
Fig. 6. After 20 years, 20 of the original 25 posts receiving the zinc chloride treatment are still useable; four of the posts that failed were ponderosa pine.
