Stream Channel Conditions and Fallen Old-Growth Redwood Trees in Humboldt Redwoods State Park

February 24, 2003

**California Department of Forestry
and Fire Protection**

Executive Summary

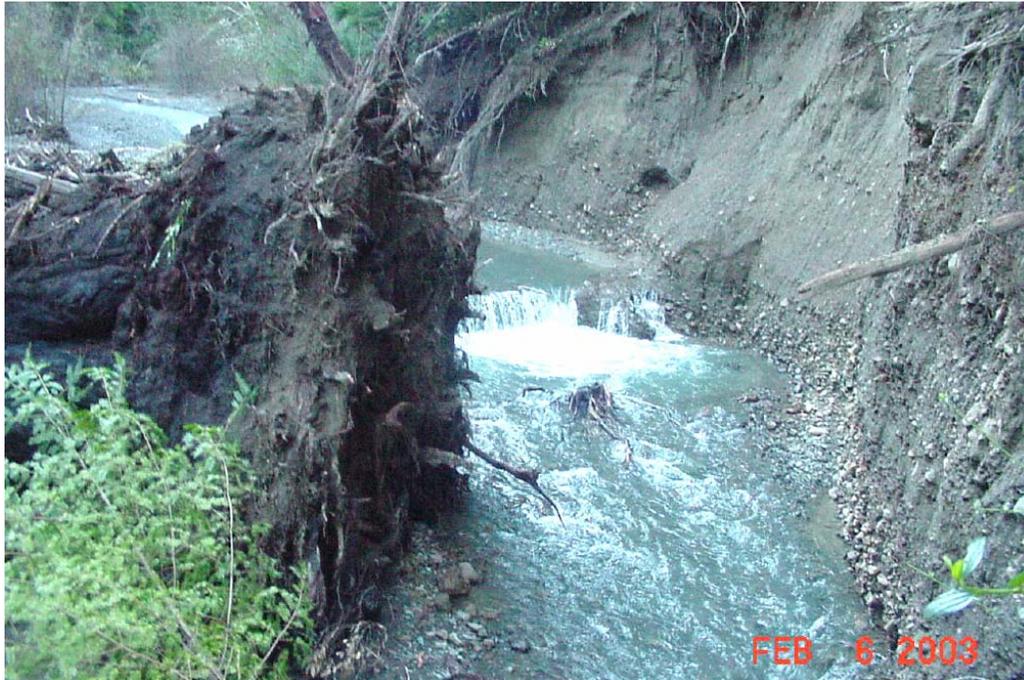
Figure A-1. Root wad from the large double old-growth redwood tree which fell in the Bear Creek watershed in December 2002.

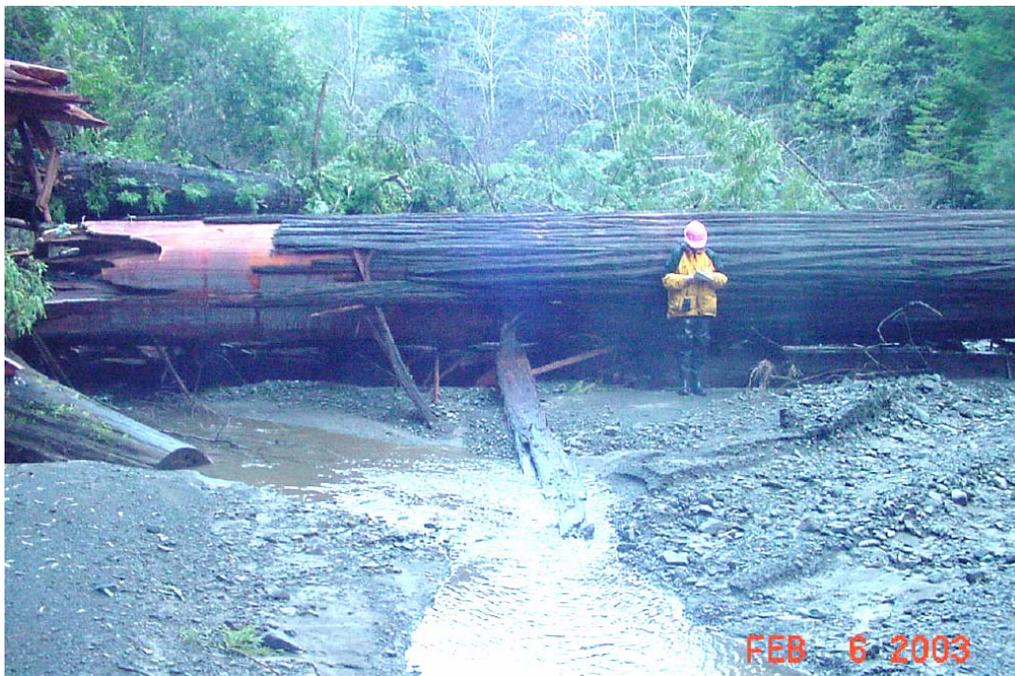
Figure A-2. The bole of the larger old-growth redwood tree which fell in the Bear Creek watershed in December 2002.

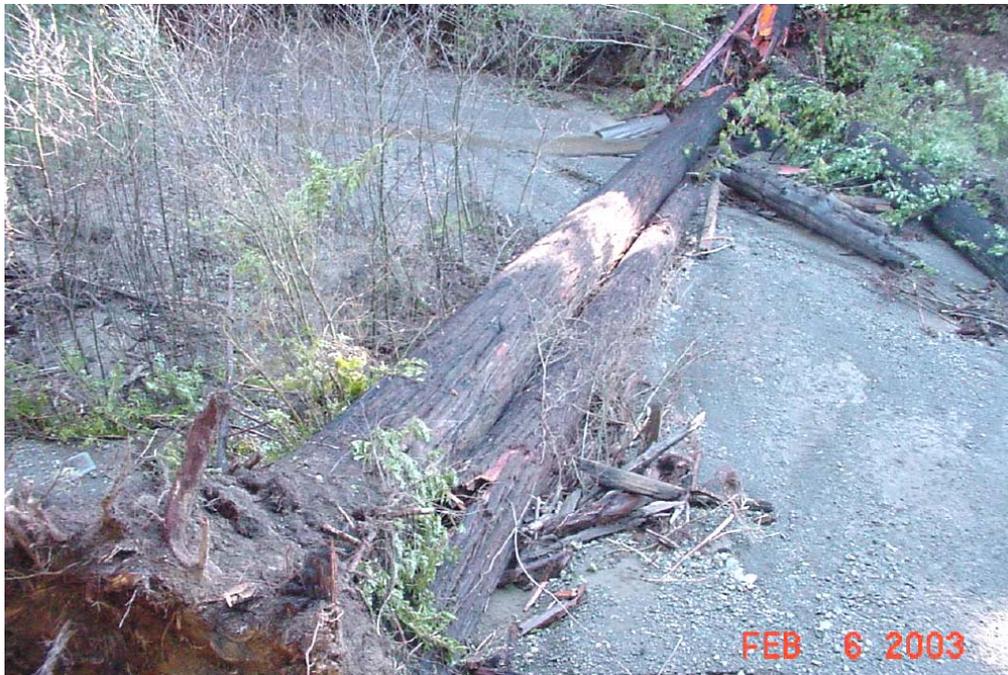
Figure A-3. View of the large double old-growth redwood tree in the Bear Creek watershed from above the active channel zone.

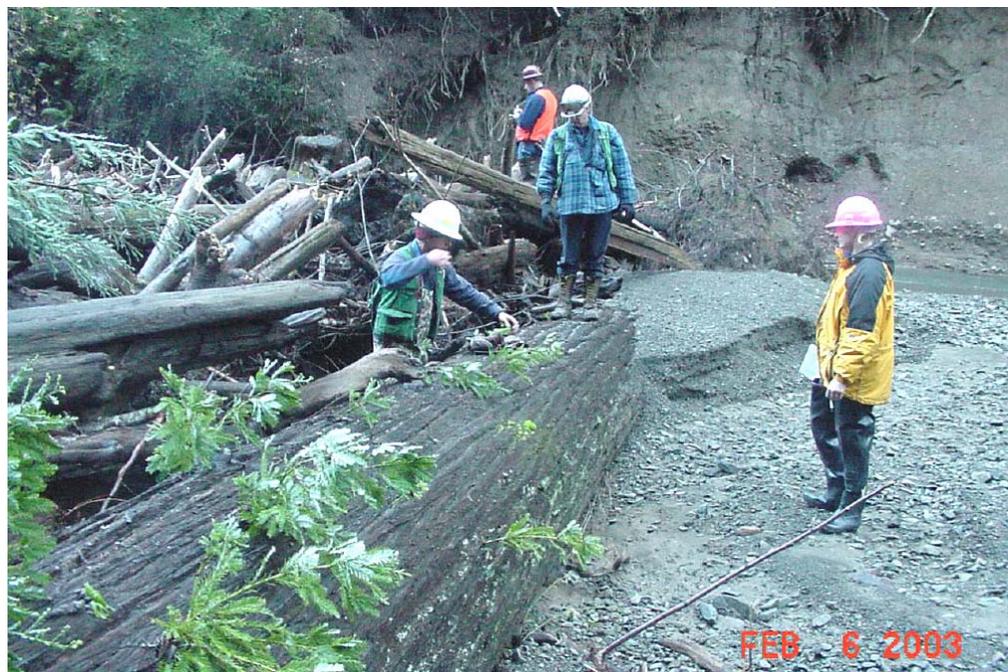
Figure A-4. Field team investigating the redwood tree which fell between 1997 and 2000 and caused the accumulation of large wood immediately above the site where the large double redwood fell in the Bear Creek drainage in December 2002.

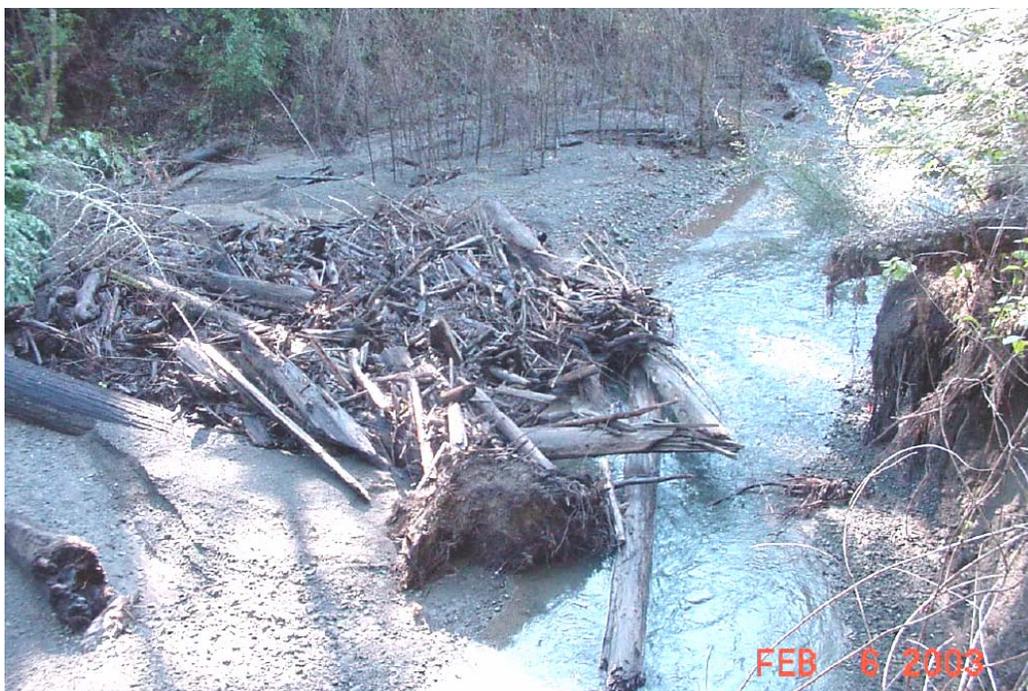
Figure A-5. View of the redwood which fell between 1997 and 2000, and the debris jam which accumulated above it from above the active channel zone.

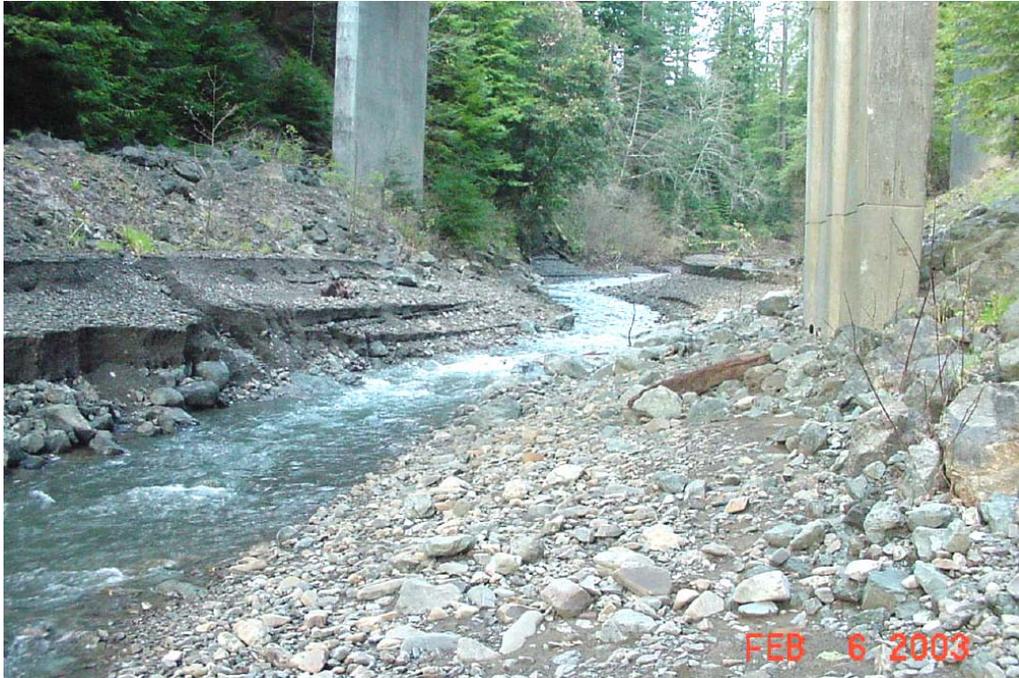
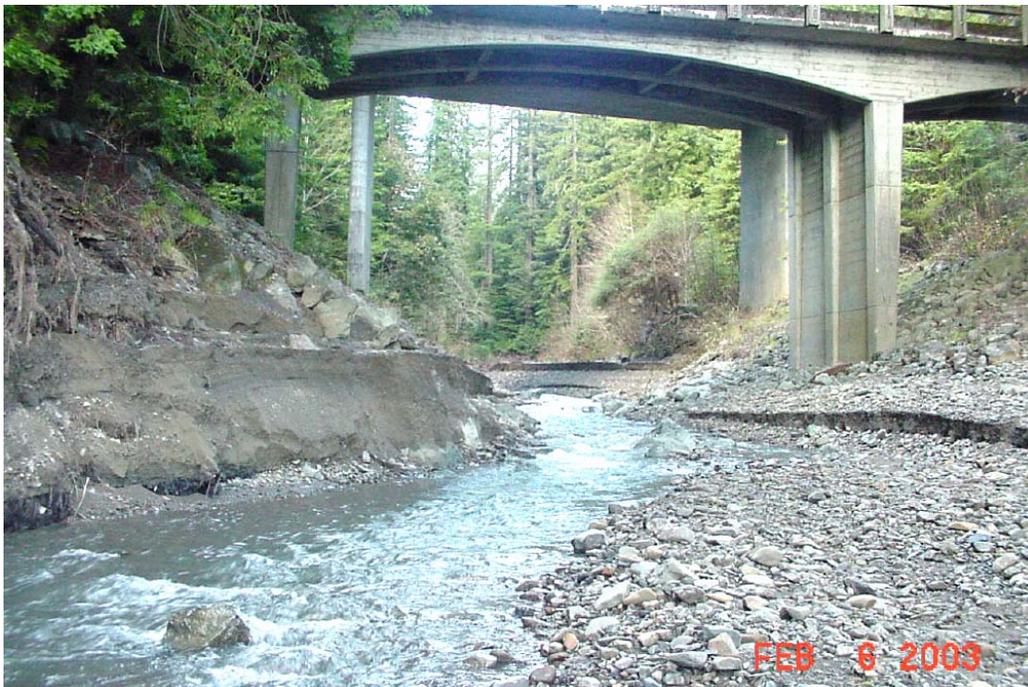
Figures A-7 and 8. Lower Bear Creek near the Avenue of the Giants Bridge showing downcutting through past coarse sediment deposits.

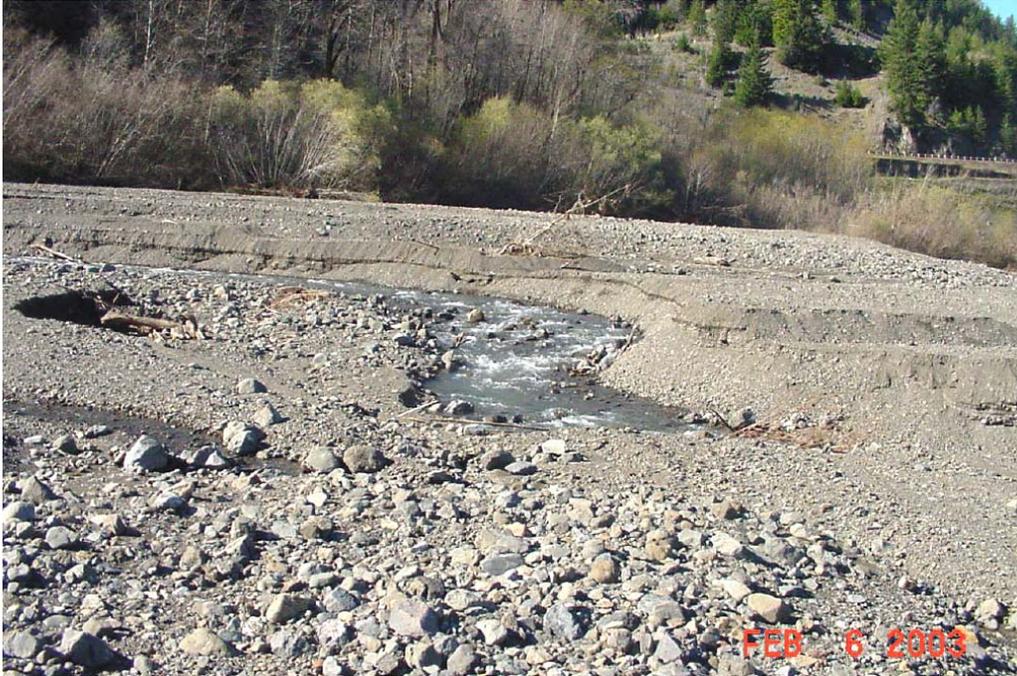
Figure A-9. Lower Jordan Creek near the entrance into the Eel River.

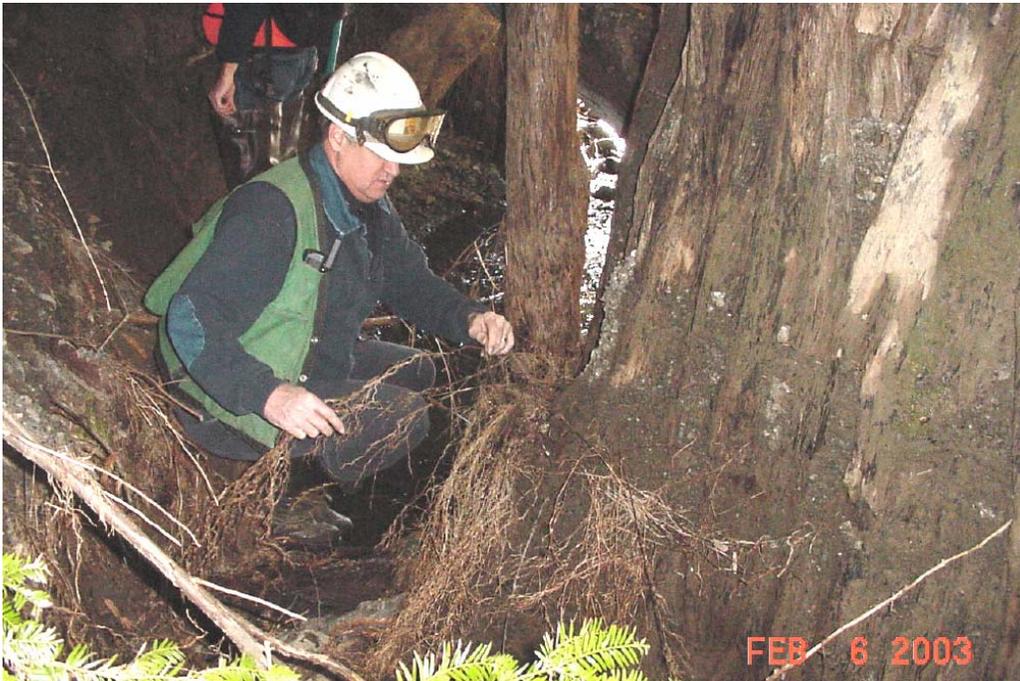
Figure A-10. Lower Jordan Creek redwood tree with adventitious roots exposed by recent downcutting.

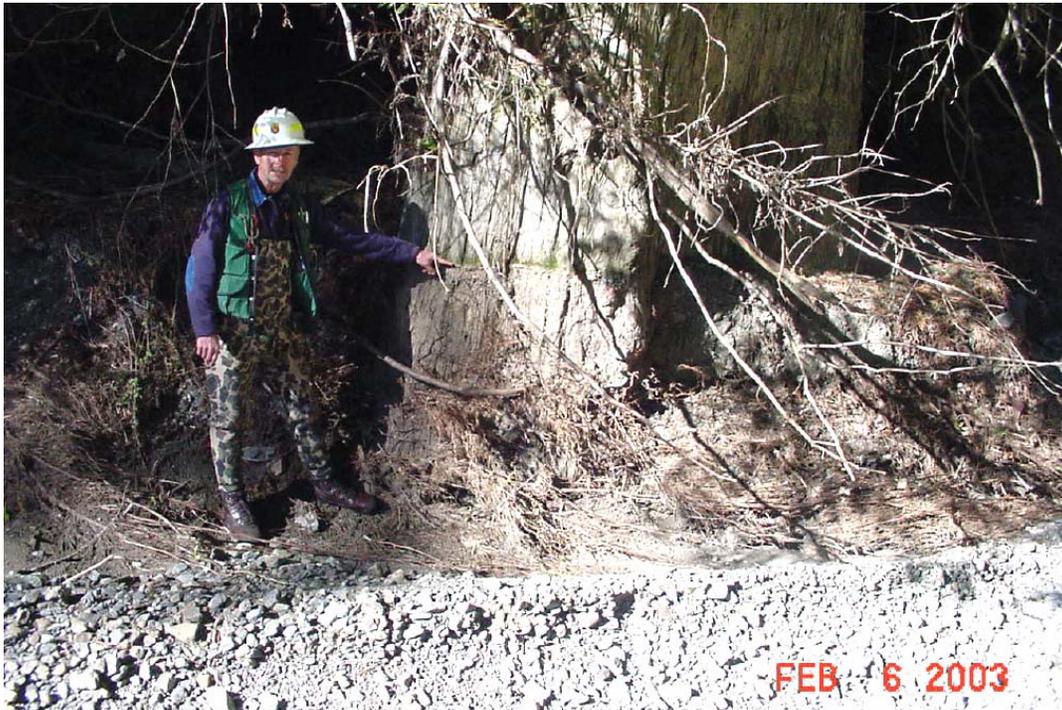
Figure A-11. Lower Jordan Creek redwood tree with adventitious roots exposed by recent channel downcutting.

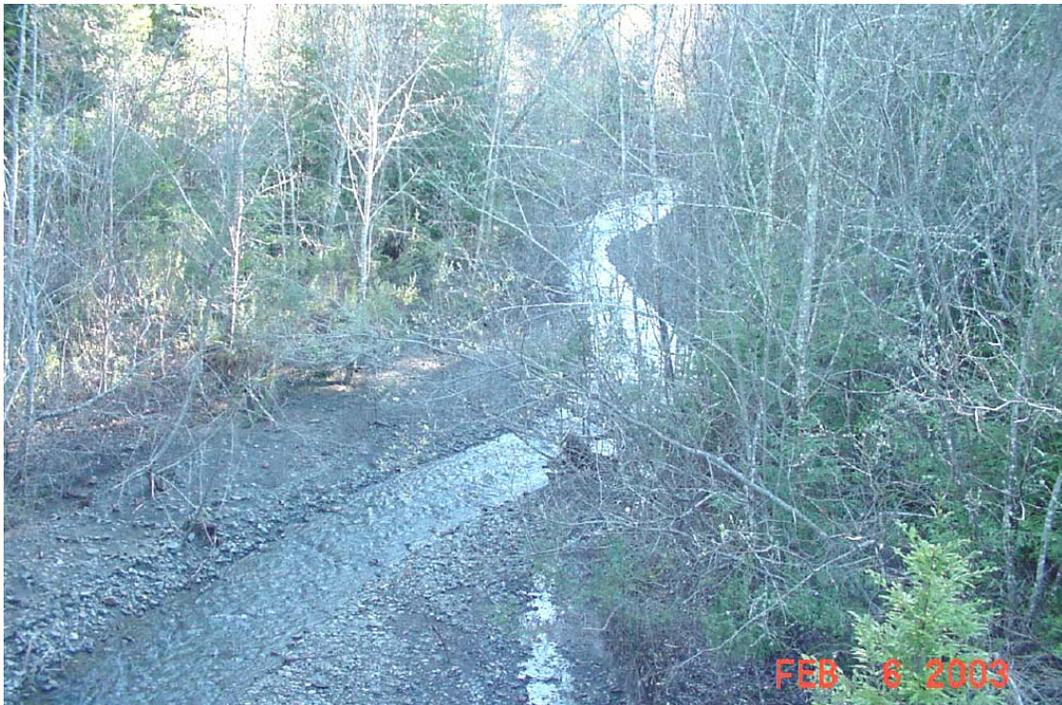
Figure A12. Lower Greenlaw Creek from the Avenue of the Giants bridge.

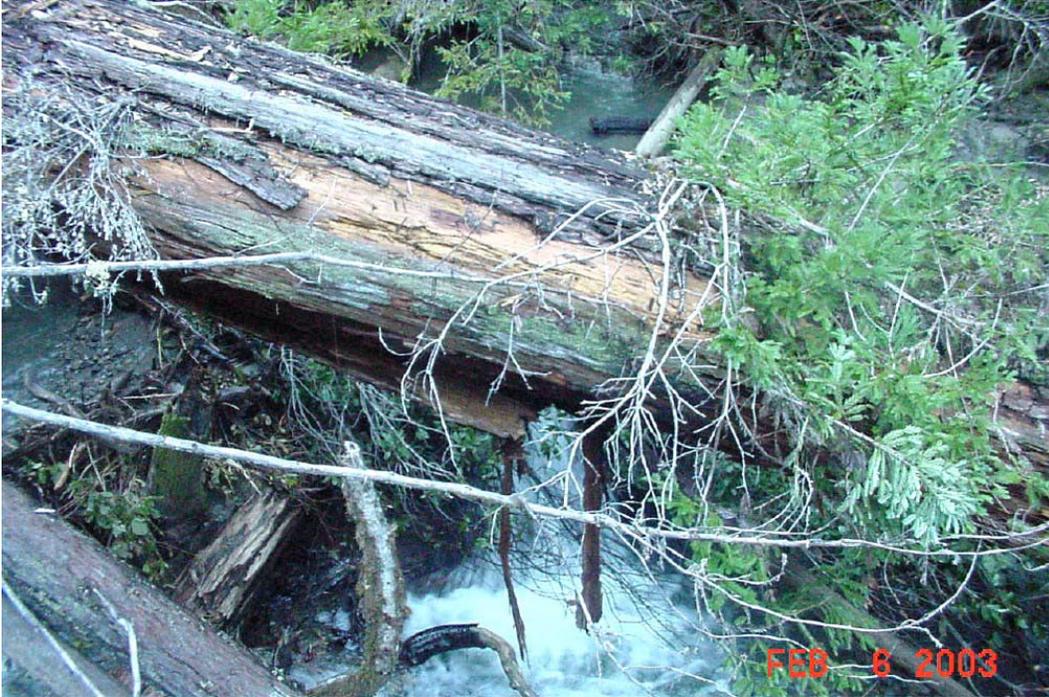
Figure A-13. Large wood which has entered the Cow Creek watershed, tributary of Bull Creek, in Humboldt Redwoods State Park.

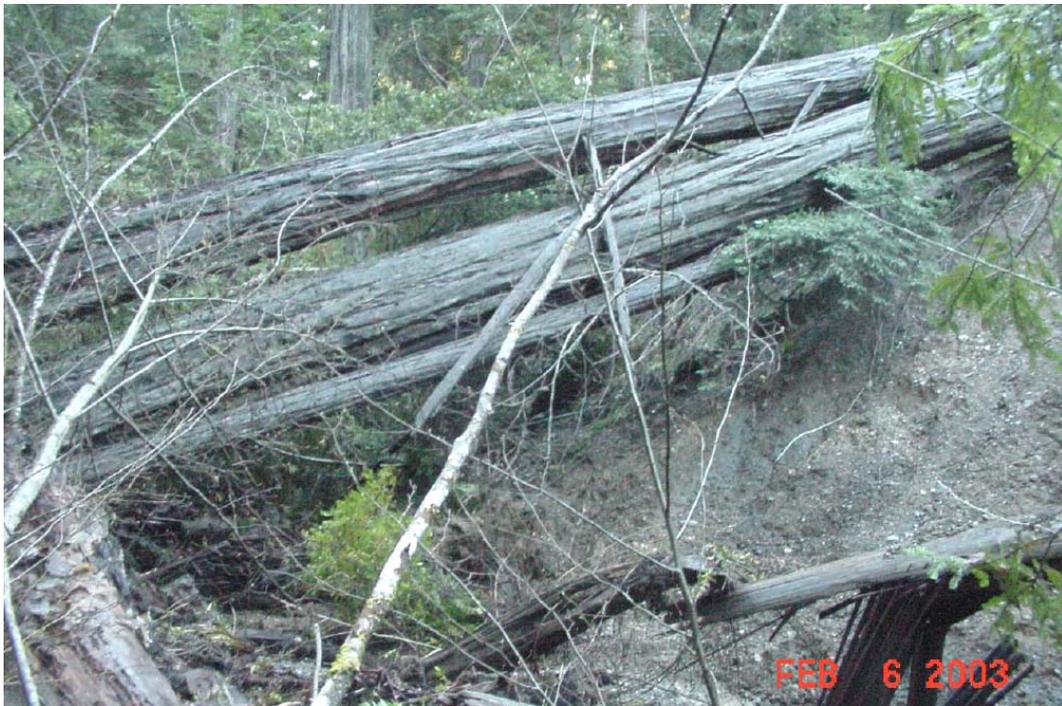
Figure A-14. Large old-growth redwoods the fell across the Cow Creek channel approximately one year ago.

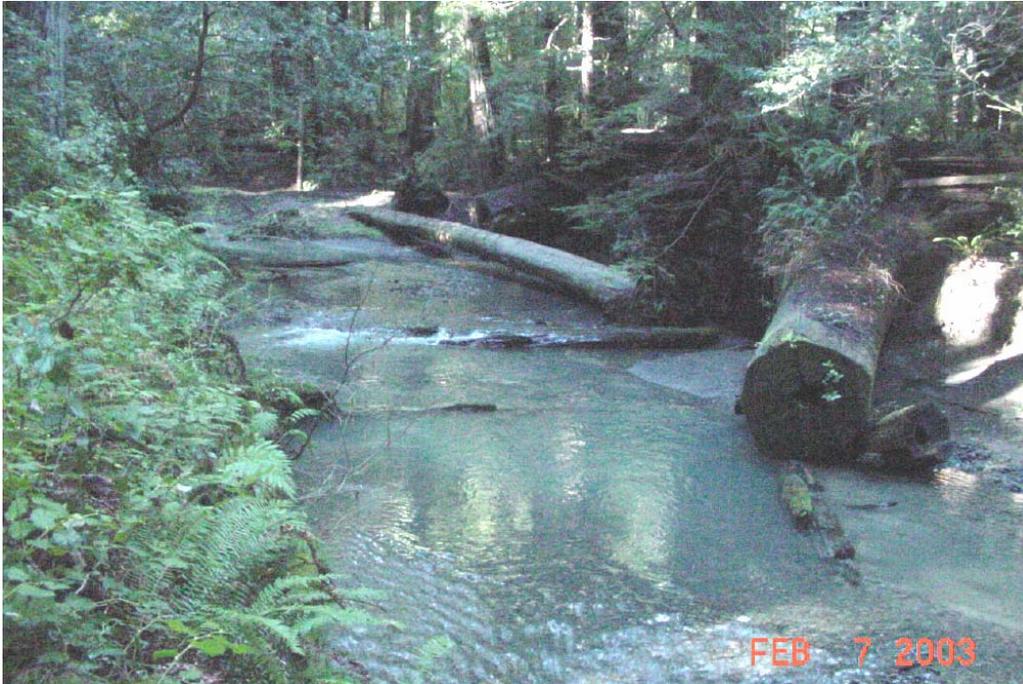
Figure A-15. Lower portion of the Squaw Creek basin, tributary of Bull Creek in Humboldt Redwoods State Park. Note evidence of removal of large wood which probably occurred in the 1960s or 1970s.

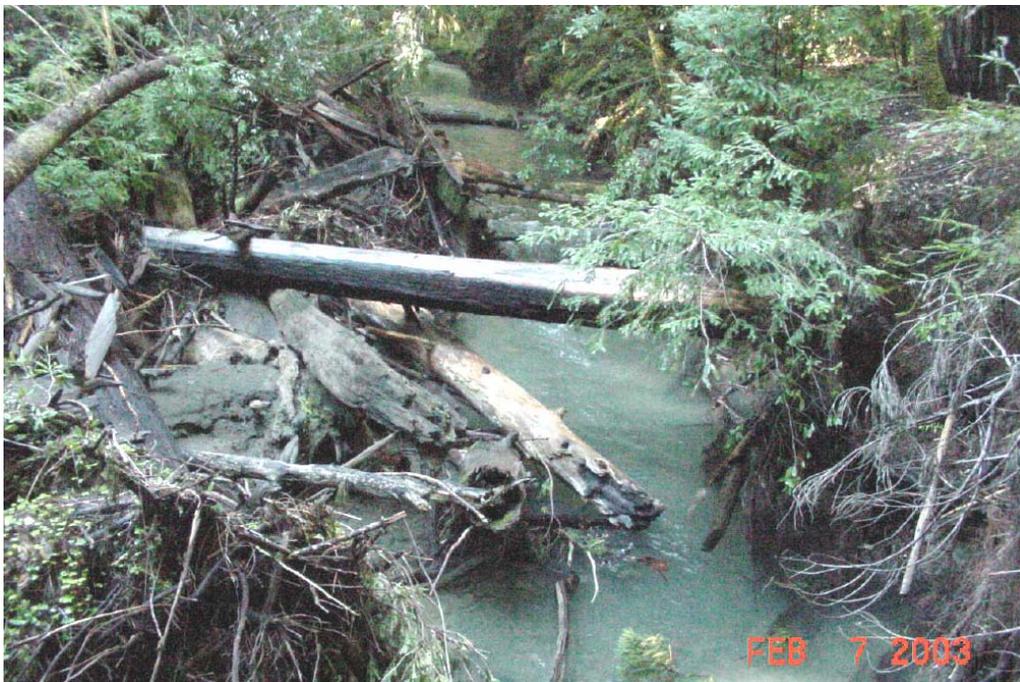
Figure A-16. Lower portion of Squaw Creek approximately 700 feet from the mouth showing accumulation of large wood which has likely entered the channel zone since stream clearance activities occurred.

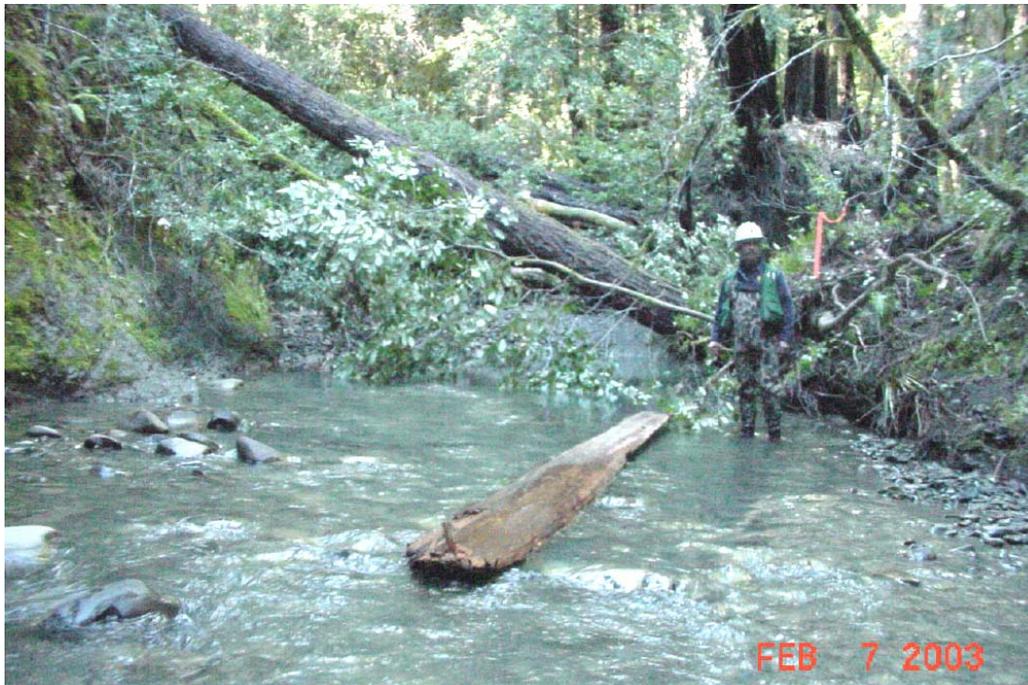
Figure A-17. Lower Squaw Creek where a Douglas-fir tree fell across the channel during the winter of 2002/2003.

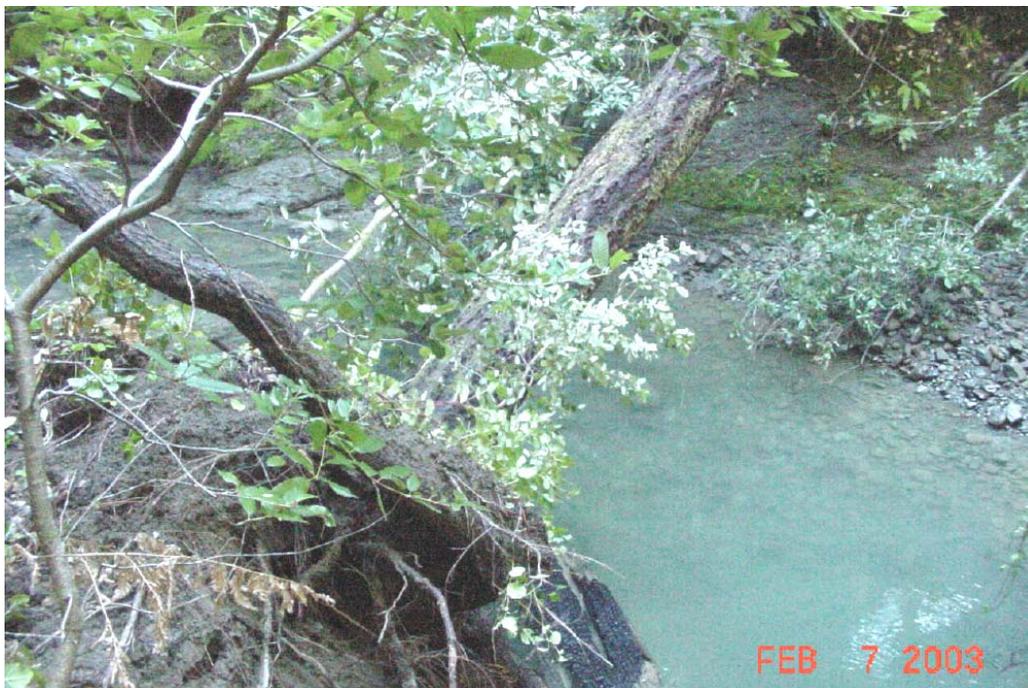
Figure A-18. Close up view of a Douglas-fir tree which entered the lower Squaw Creek channel during the winter of 2002/2003.

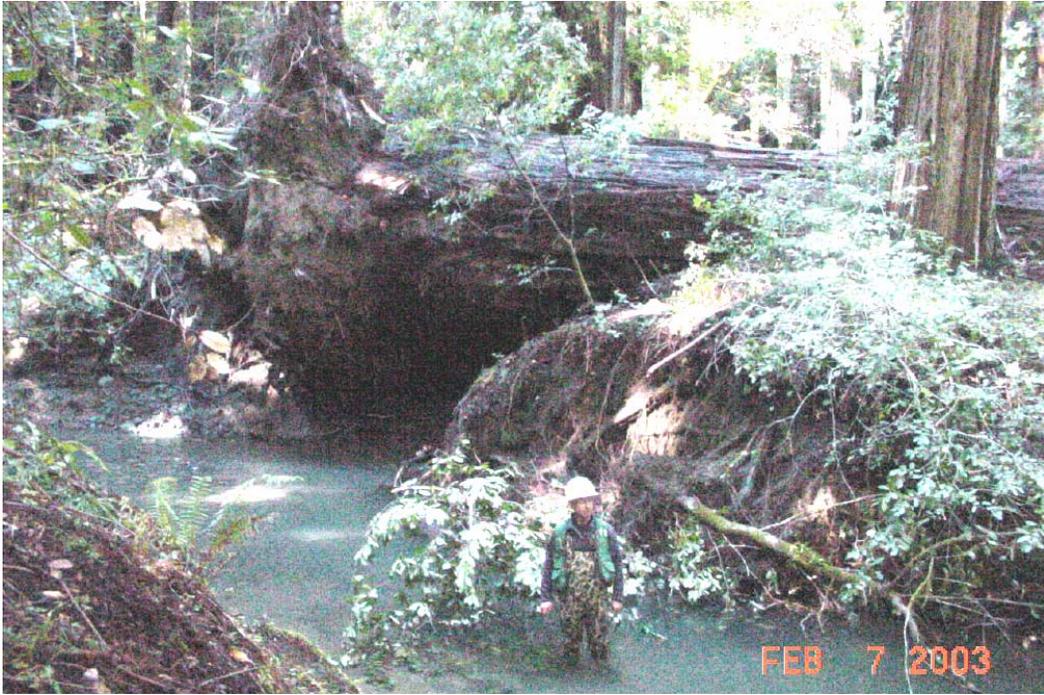
Figure A-19. Large eight foot diameter old-growth redwood which fell during the winter of 2002/2003 in lower Squaw Creek.

Squaw Creek is a tributary to Bull Creek from the south side of the Bull Creek drainage. The lower approximately one-quarter mile of the channel was investigated by the field team (Cafferata and Johnson only) above its confluence with Bull Creek. The entire observed section was on the Bull Creek floodplain. Fish habitat improvement structures were located along the length of the observed stream, with some appearing functional and others having been damaged or left suspended above the water due to changing channel conditions. At a distance of approximately 700 feet from the mouth, a 5 foot diameter redwood, originally situated on the bank of the stream, had fallen across the stream, and diverted its flow into the bank, creating a sediment source. The tree appears to have fallen a few years ago, perhaps during the 1997 storm event. Two Douglas-fir trees (26 and 14 inches in diameter) in this general area fell during the December 2002 storms, depositing additional sediment in the stream. At approximately 1,200 feet upstream from the mouth, an 8 foot diameter (estimated) old-growth redwood situated at the edge of the channel fell away from the stream, leaving its root wad suspended over the stream.⁶ The Squaw Creek channel was not examined above this fallen 8 foot tree.

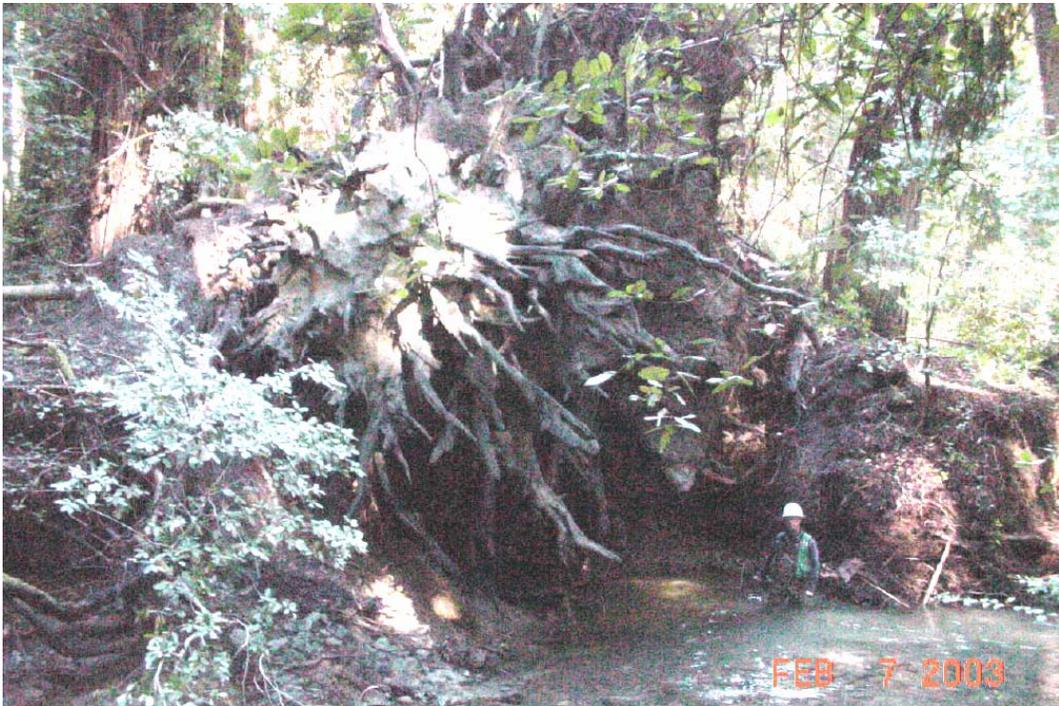
Figure A-20. Root wad from the large old-growth redwood tree which fell in lower Squaw Creek during the winter of 2002/2003.
